**SITE INVESTIGATION**

**AT WESTCLIFF**

**WESTON**

**PORTLAND**

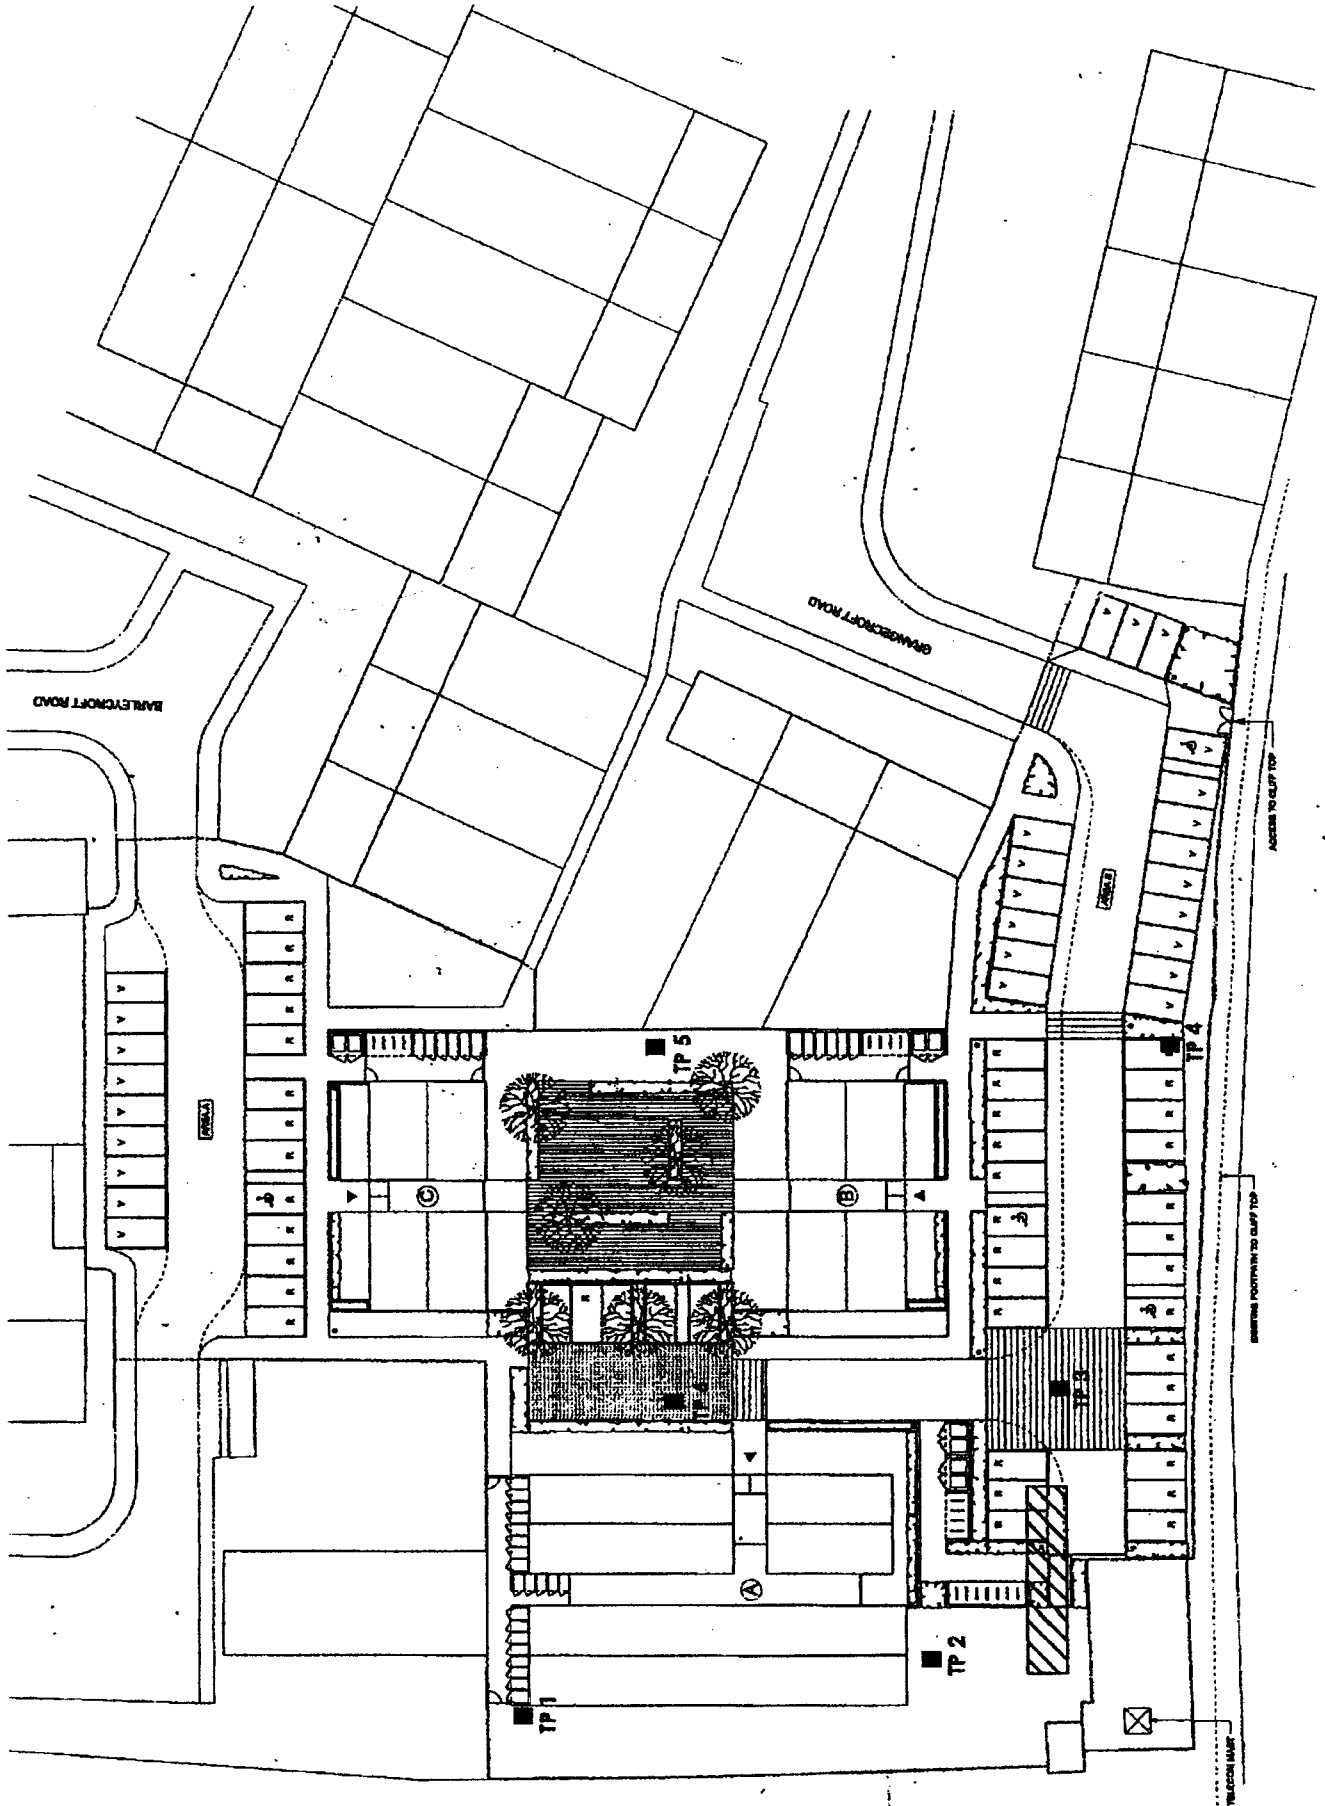
WESTCLIFF, WESTON, PORTLAND SITE INVESTIGATION  
TRIAL PITS LOCATION

Six trial pits were excavated in the approximately square middle area of the site. The location of trial pits was limited by services in the area and current usage of the site.

All the trial pits found marl and limestone rubble above solid limestone which the excavator could not penetrate at depths varying between 1.8 metres and 2.5 metres. Some made ground was encountered to a depth of 700 mm at trial pits 5 and 6 near the centre of the site.
